Navajo Abandoned Uranium Mine

Site Screen Report

Kings 6 AUM Site

March 2010

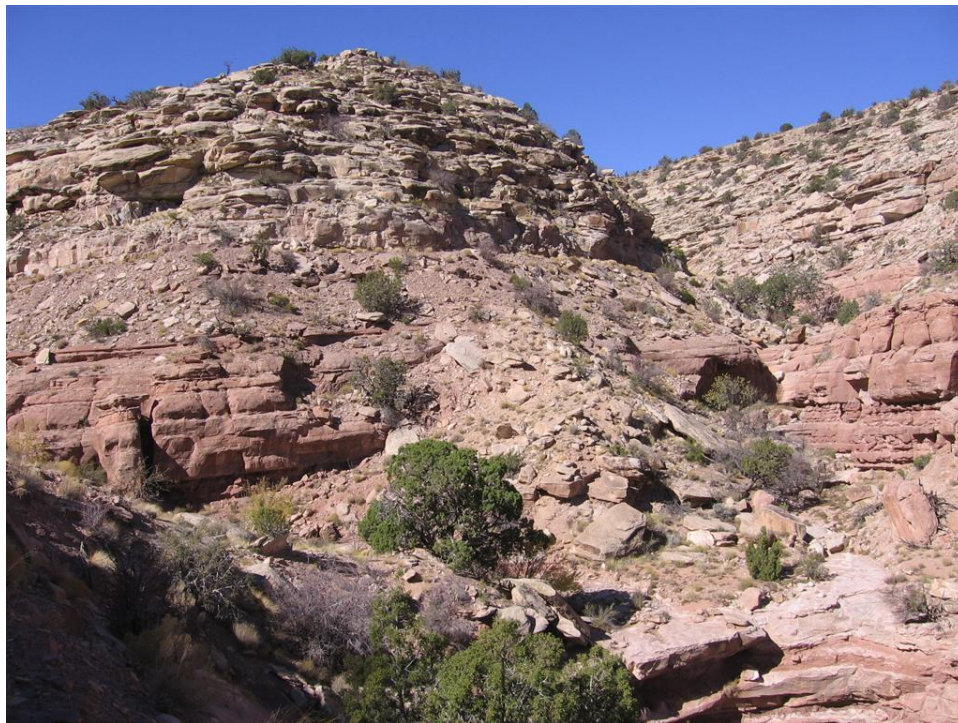
Photo 1. Cliff side below adits, with waste rock

Waste pile sloughing off down road beneath adit, 100'x75', with a total estimated volume of 1,389 yd³

Unreclaimed waste pile; 2 sealed adits

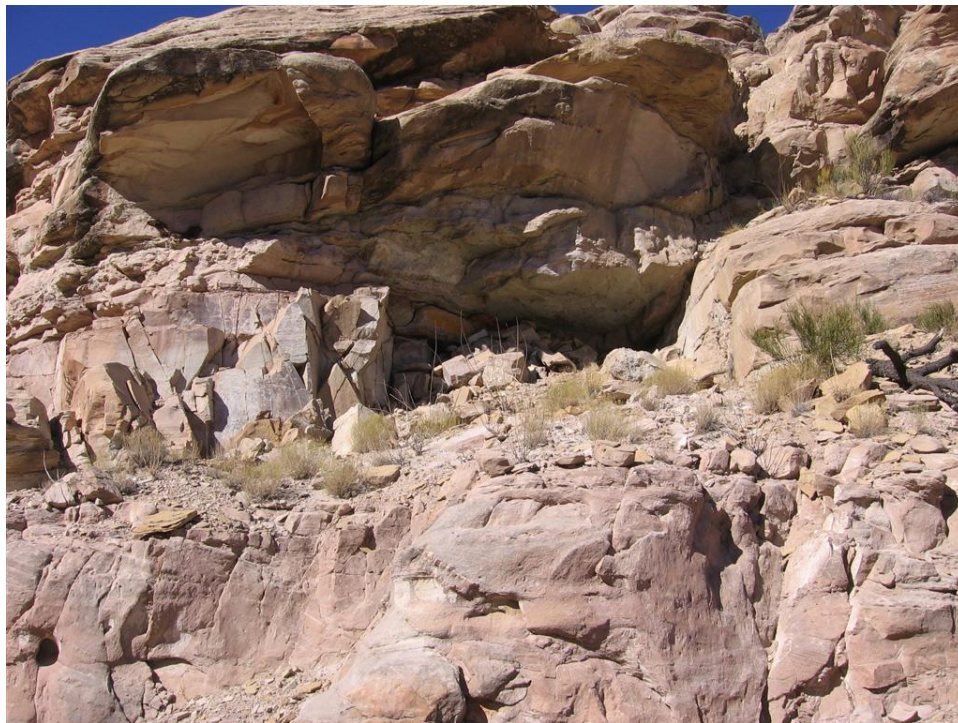
Photo 2. Sealed adit

2 adits, approximately 6' x 8', reclaimed with stone and poly-foam

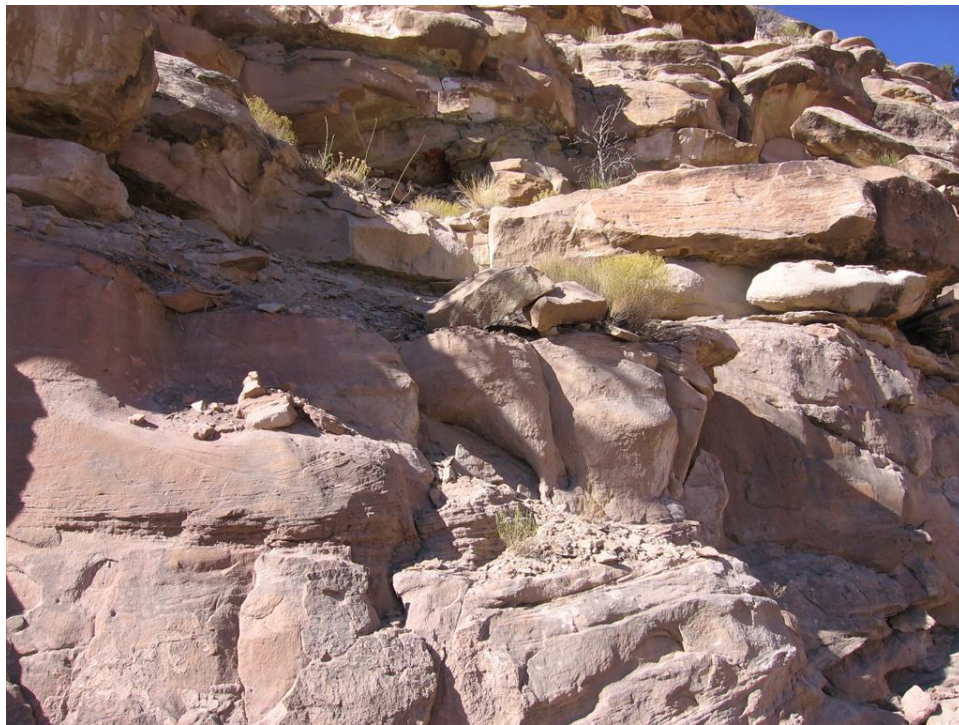
Photo 3. Waste rock below adit

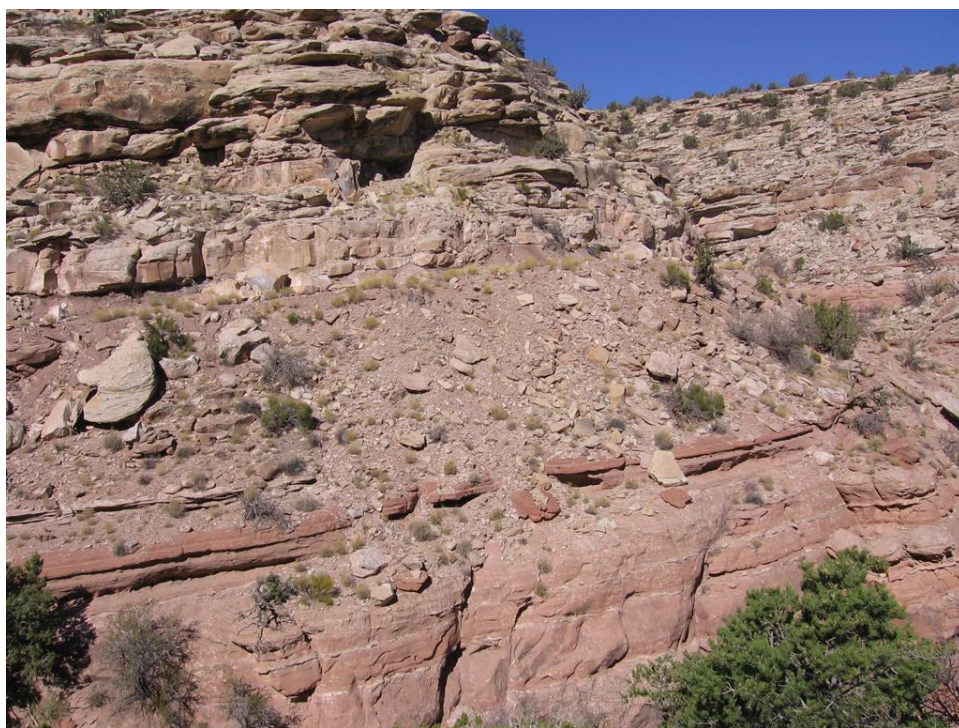
Photo 4. Cliff side below adits, with waste rock
